**JCAA/JG-PP No-Lead Solder Project:
-55°C to +125°C Thermal Cycle Testing Final Report**

Rockwell Collins Advanced Manufacturing Technology Group

**Contract: GST 0504BM3419
Subcontract: BM3419-02**

**May 28, 2006
Revision B**

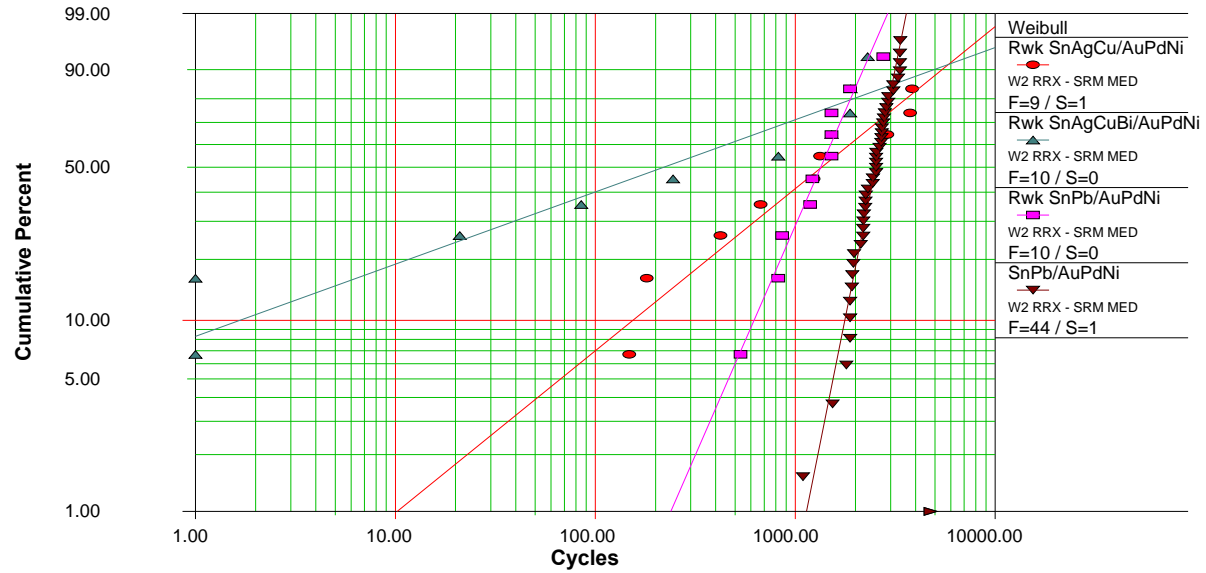
Figure 14 TQFP-208 all combination results for legacy ("Rework") test vehicles (140°C Tg)

On the legacy (“Rework”) test vehicles (140°C Tg), the reworked TQFP-208 components had significantly shorter life (> 700 thermal cycles) than the non-reworked TQFP-208 components (Figure 14). Figure 15 illustrates the poor performance of the reworked SACB solder alloy in comparison to SAC and SnPb. A review of the TQFP rework protocol revealed a likely cause of poor reworked components performance – the TQFP component was the last of a group of 4 components reworked in a closely grouped test vehicle region. The TQFP component pads were oxidized during the replacement soldering of the other three components thus impacting the TQFP rework final solder joint integrity.

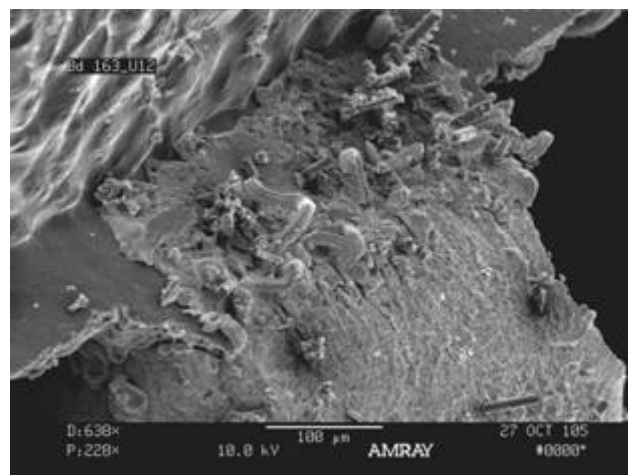
Figure 20 thru Figure 24 illustrates typical tin whiskers found on the TSOP-50 components with SnCu surface finish. This TSOP-50 component was from the legacy (“Rework”) test vehicle. It was originally reflow soldered with a SnPb solder alloy and then manually reworked with a SAC solder alloy as part of the overall rework impact segment of the investigation test matrix (Figure 2). Tin whiskers were found on lead surfaces that were not soldered (the upper knees of the component leads and lead faces) and would be characterized as dense fields with a “worm-like” appearance. SEM EDX analysis was used to confirm that the whiskers were comprised of tin (Figure 25: note gold (Au) presence due to SEM preparation procedure).

Figure 21 SEM image of TSOP component with SnCu surface finish showing tin whiskers on upper knee of lead

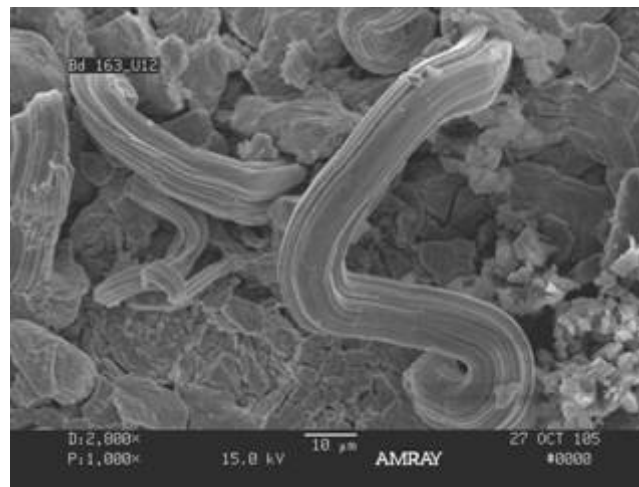
Figure 22 SEM image of TSOP component with SnCu surface finish showing tin whisker on upper knee of lead

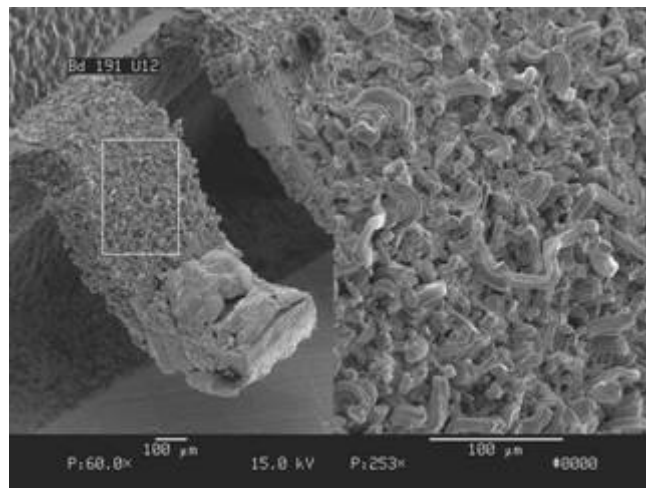
Figure 23 SEM image of TSOP component with SnCu surface finish showing tin whiskers on lead face

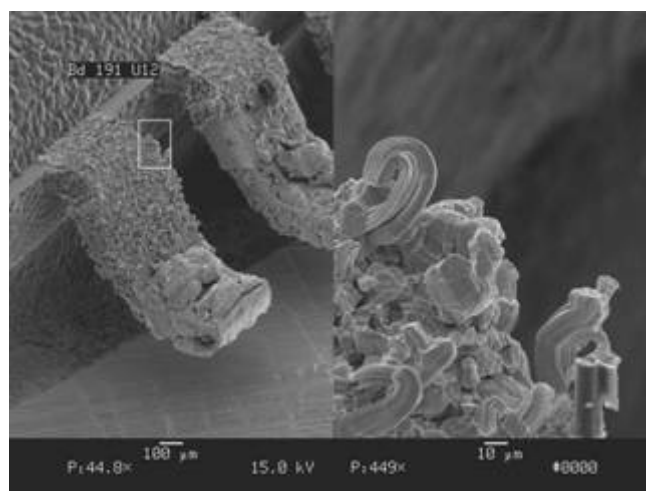
Figure 24 SEM image of TSOP component with SnCu surface finish showing tin whiskers on upper knee edge of lead

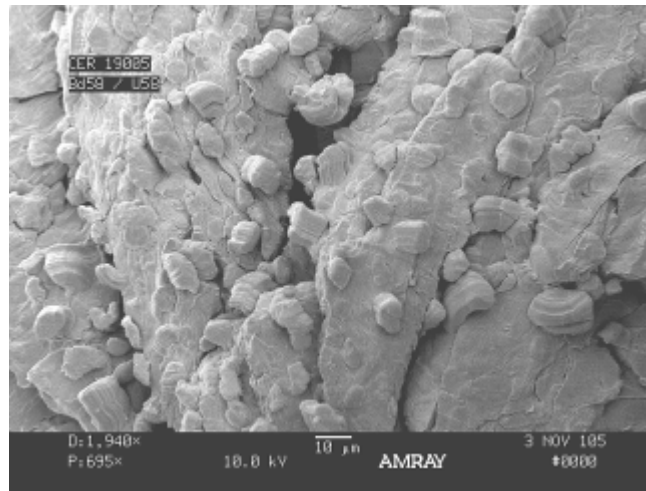
Only a handful of whiskers were observed on the TQFP-144 components for all of the test vehicles. However, the whiskers observed were of significant interest. Figure 26 thru Figure 28 illustrate a TQFP-144 component, with a matte tin surface finish, on a legacy (“Rework”) test vehicle that was soldered with SnPb solder. Small lead (Pb) whiskers were found on the upper knee of the component lead. The Pb whisker phenomena were also observed sporadically on the TSOP-50 components with SnPb surface finish (Figure 29 thru Figure 31). The Pb whiskers observed in this investigation were significantly larger than whiskers found on SnPb finishes documented in other industry investigations [9].

Figure 27 Magnified SEM image of whiskers, TQFP component with matte tin surface finish

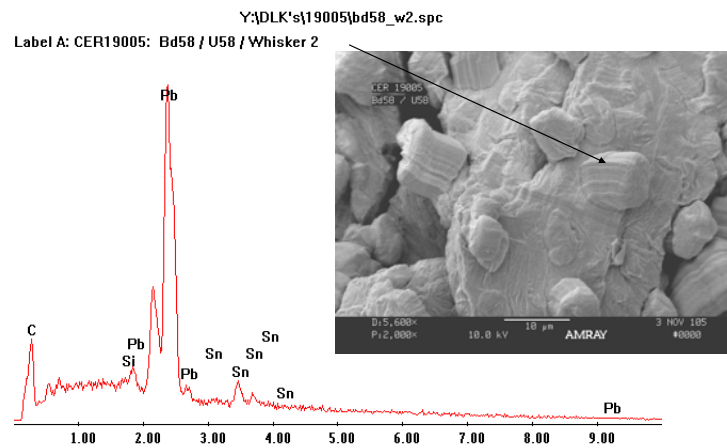
Figure 28 SEM EDX scan of an individual whisker, TQFP component with matte tin surface finish, showing Pb chemical composition

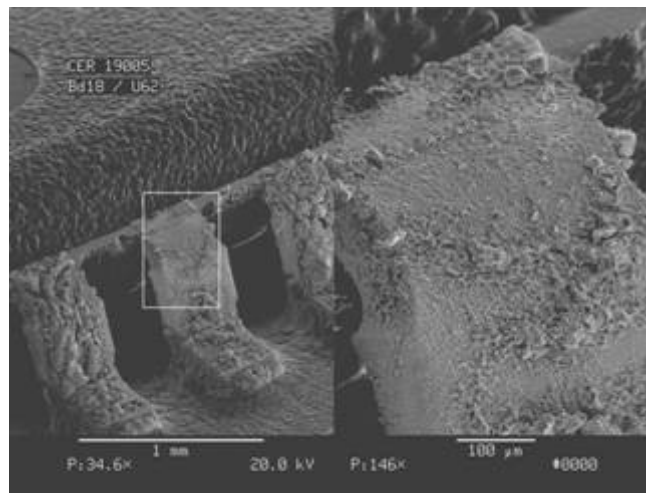
Figure 29 SEM image of TSOP component with SnPb surface finish showing whiskers on upper knee of lead

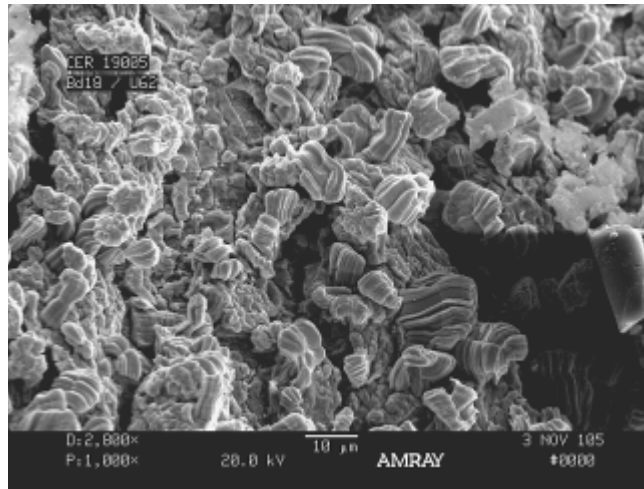
Figure 30 SEM image of TSOP component with SnPb surface finish showing whiskers on upper knee of lead

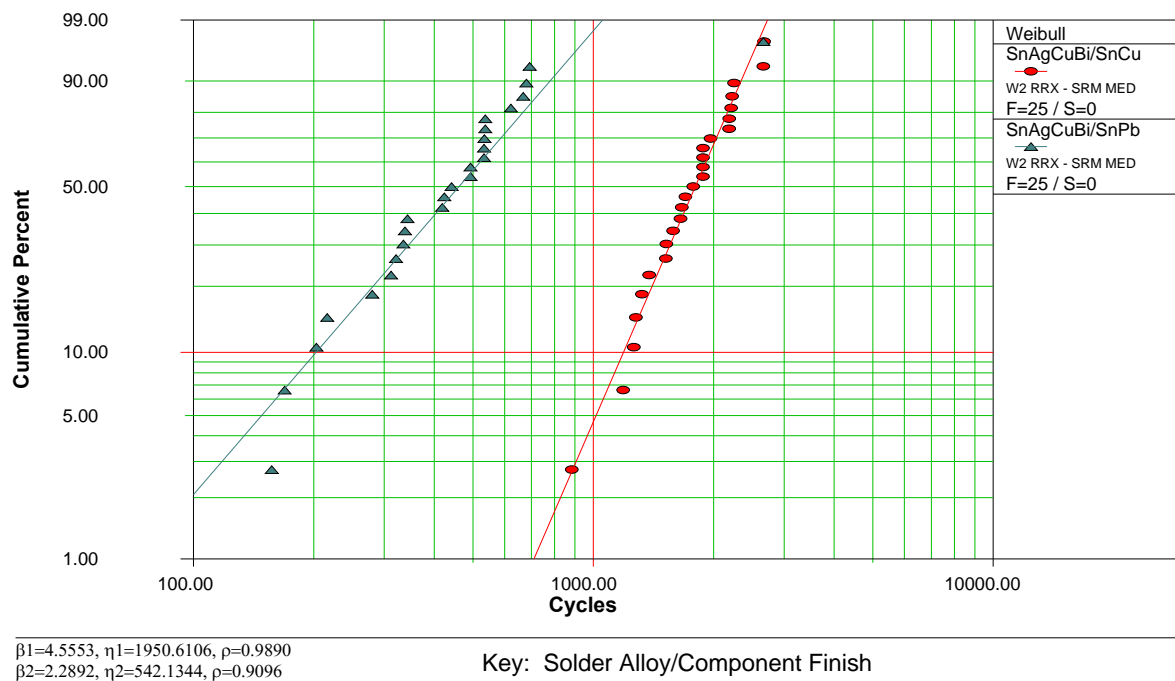
Figure 32 TSOP-50 SACB test results for the “Manufactured” test vehicles (170°C Tg)

Optical microscopy and scanning electron microscopy (SEM) inspection of a sample of the failed TSOP-50 SACB-SnPb solder joint combination was conducted. No evidence of a SnBiPb microstructural phase was observed. SEM elemental mapping was conducted on a sample of the failed TSOP-50 SACB-SnPb solder joints. Figure 33 illustrates the typical results for the mapping. No segregated SnBiPb microstructural phase regions were found. Some small segregated regions of Pb were observed in the solder joints.

The authors have hypothesized two potential root causes responsible for the Pb contamination impact on the TSOP-50 SACB solder joint integrity based on the completed failure analysis results:

1. The Pb contamination is impacting the SACB solder joint integrity by the formation of non-equilibrium SnPbBi microstructure phases. The Pb contamination is not great enough to form the microstructure phases associated with the 58Bi42Sn solder alloy (138C), the 16Sn32Pb52Bi ternary eutectic phase (96C) or the 62.5Sn/36.1Pb/1.4Ag ternary eutectic alloy (177°C) [15]. However, Whitney and Corbin [16] have reported that ternary reactions are very sensitive to small Pb additions for SnBi solder alloys. The formation of non-equilibrium ternary phases can cause broad melting effects on the melting behavior on solder alloy solidification. The DSC data of this investigation shows a nondescript impact rather than a specific ternary reaction in a similar manner.

2. The DSC test results may be an indication of the Sn63Pb37 eutectic alloy development at the solder joint grain boundaries. The development of the Sn63Pb37 alloy at the grain boundaries would impact the thermal cycle solder joint integrity. The SEM elemental mapping did show some evidence of segregated Pb regions in the SACB solder joint thus the existence of the eutectic alloy at the grain boundaries would be possible. Table 6 illustrates the impact of TSOP Pb contamination of a SnAgBi solder alloy reported by ATT/Sandia National Laboratory [17]. The thermal cycle conditioning parameters were 0°C to 100°C, 15 minute dwells and 20°C/minute ramps. The pull test cross head speed was 9 mm/minute. The pull strength of the Pb contaminated solder joints was degraded in comparison to the non-contaminated case.
